## Drawworks Cable Clamp

### Issue

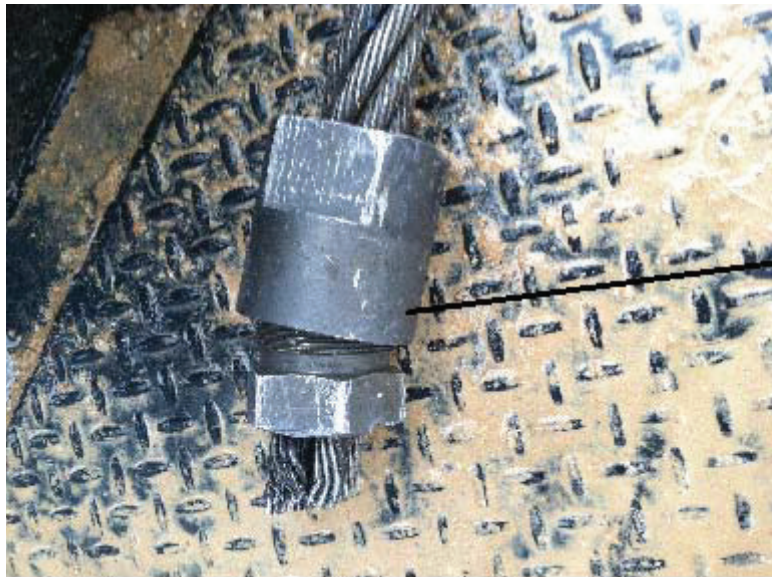
P/N 47774

If the cable clamp is installed incorrectly, the pigtail can be caught on the brake assembly when running in either direction. The cable clamp (see Figure 1) can be pulled through the retainer plate, breaking the weld (see Figure 2 on page 2), damaging the drum flange, and striking the brake caliper.

Figure 1: Cable Clamp.

Canrig recommends the installation of a secondary cable retention system. Install the cable such that 1–2 in. of cable extends beyond the second bracket (P/N DT20763) (see Figure 3). Turn the drum slowly in both directions to verify cable clearance and proper drawworks operation.

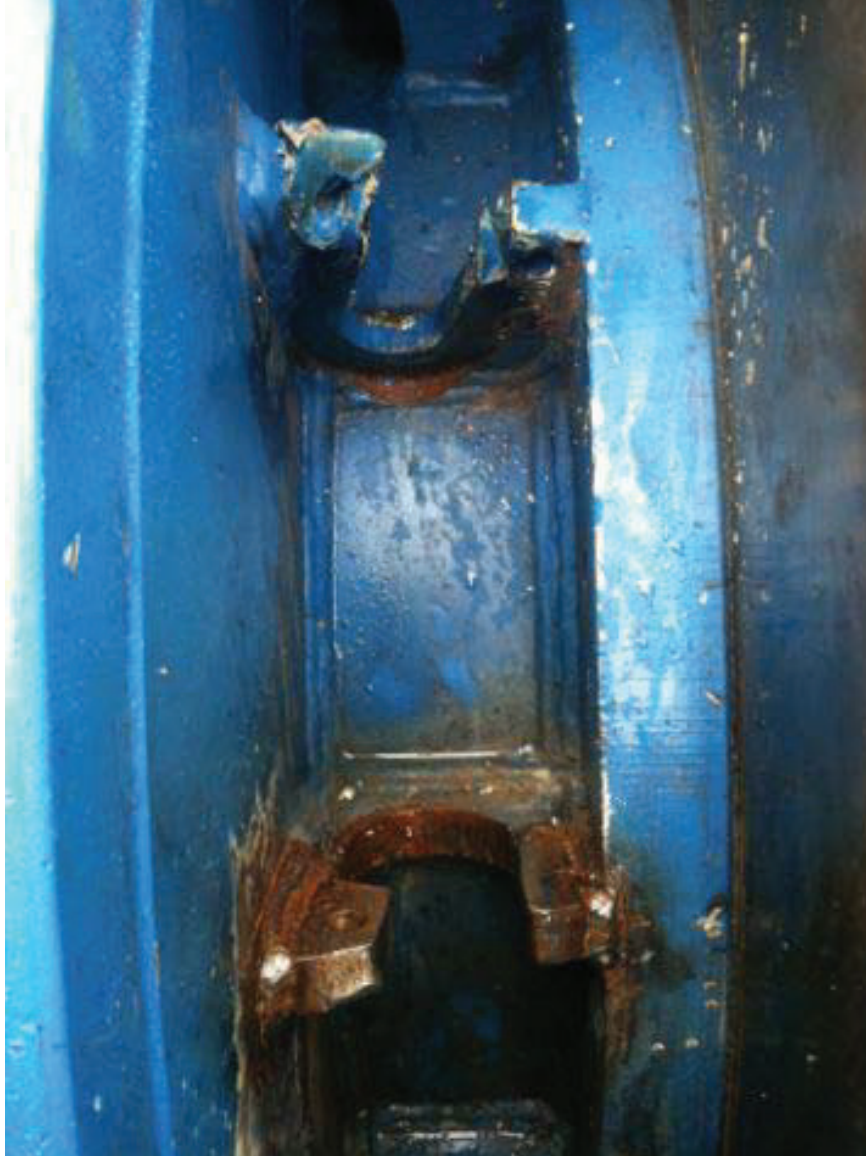
Figure 2: Broken Weld

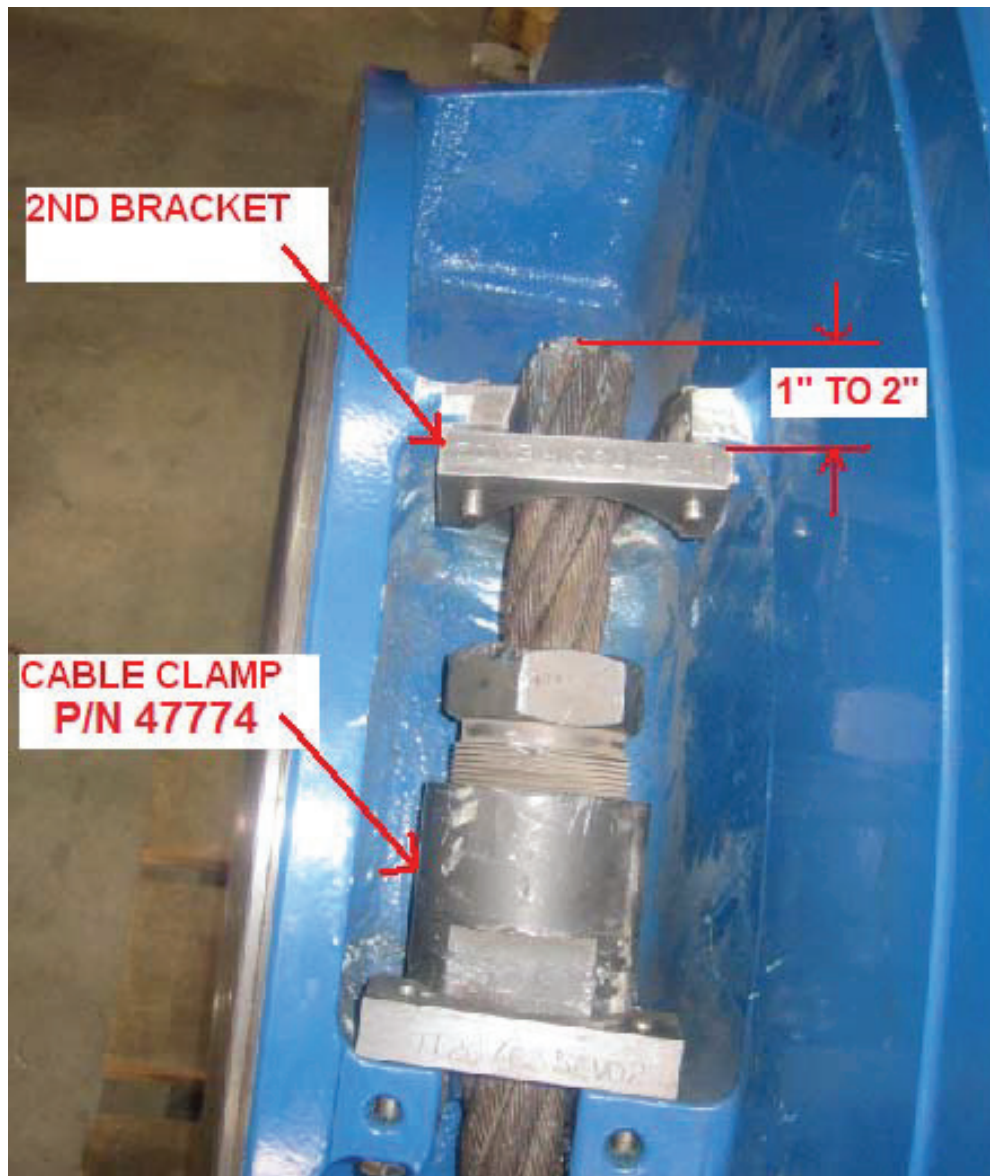
Figure 3: Secondary Cable Retention System
