| Model: Top Drive Serial #: 1161-1349 | Feb. 14, 2017 |
| Product Bulletin #: TDS-165 | |

Top Drive Plenum Heater

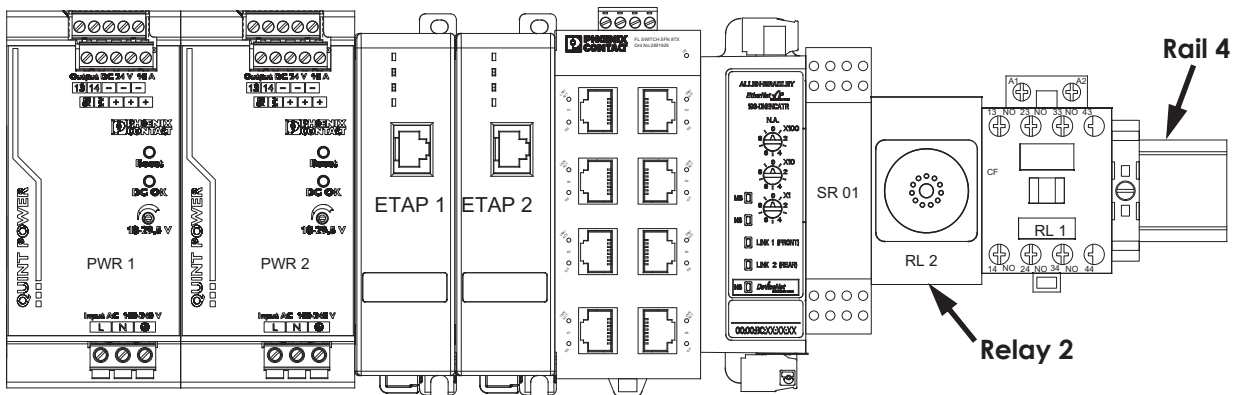
The top drive heater (condensation) has been found to not operate correctly on several delivered units in the field. Further investigation has found that the heater relay circuit has been wired incorrectly due to inaccurate schematics on some top drives.

Figure 1: Relay 2 is located on Rail 4 in the CIP

1. Remove all power to the Top Drive CIP (Control Interface Panel). Perform Lock-out/Tag-out (LO/TO) procedure before proceeding.
2. Using multimeter, ensure there is no voltage present to the cabinet and Relay 2 located on Rail 4 (See Figure 1 on page 2).
3. Inspect Relay 2 to ensure wiring is correct. For correct wiring see Figure 2 on page 3:
 - a. If wiring is correct, perform Step 8 on page 2 and reverse Step 1.
 - b. If wiring is not correct, proceed to Step 4.
4. Remove wire number 160 from terminal 3 and terminate to terminal 1. Remove wire number 376 from terminal 1 and terminate to terminal 3 (see Figure 2 on page 3).
5. Remove wire number 157 from terminal 7 and terminate to terminal 6.
6. Remove wire number 178 from terminal 9 and terminate to terminal 11.
7. Reverse top drive lock out and Lock-out/Tag-out (LO/TO) procedure and test wiring.

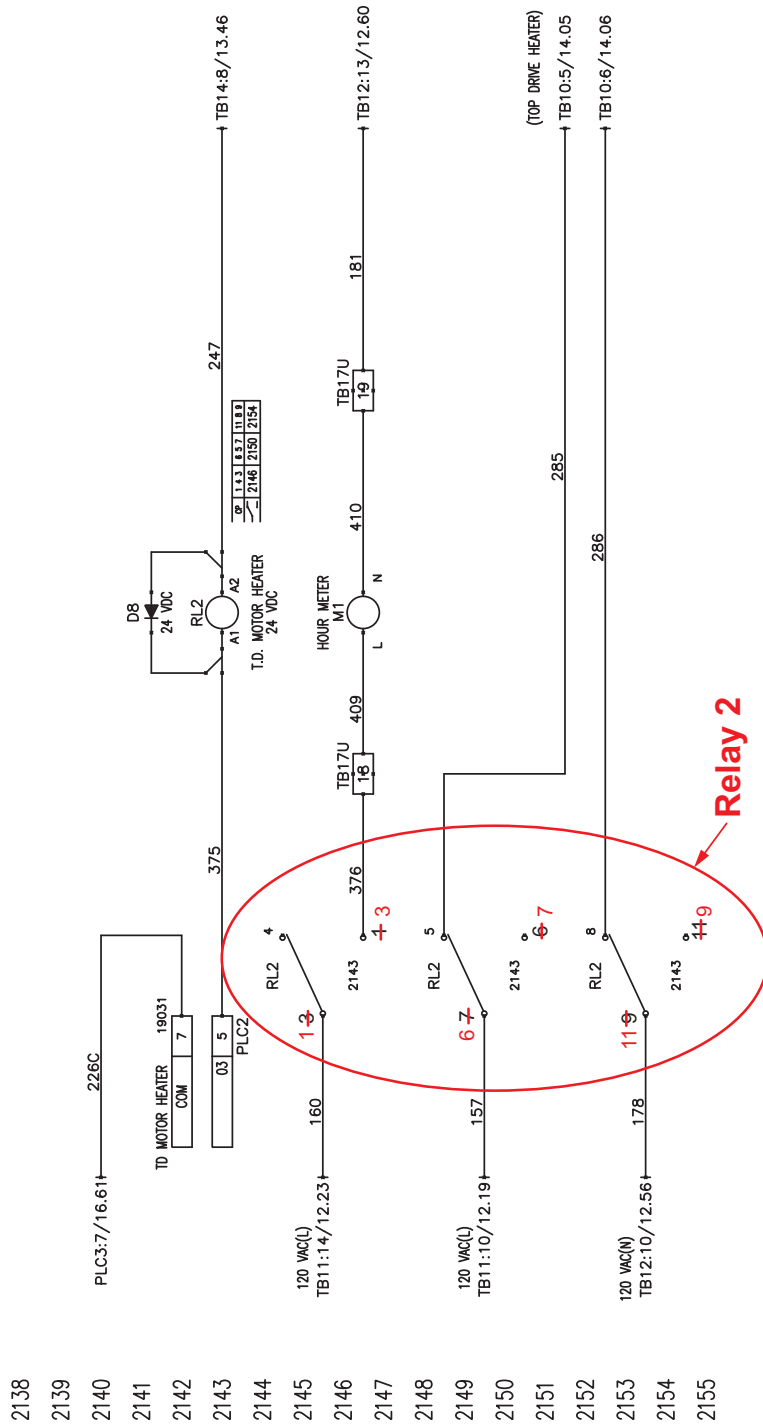
CONTROL & INTERFACE PANEL AIR TEMPERATURE/HEATERS Schematic
Page 21 - Relay 2 Detail

Figure 2: Detail of Relay 2 Connections

8. Test each circuit using the multimeter:
 - When top drive switch is in the enable position, terminal 3 on Relay 2 should read approximately 120 VAC to TB12 terminal 10. The hour meter should be running.
 - When top drive switch is in the disable position, terminals 5 to 8 should read approximately 120 VAC and the top drive motor heater should be on.
 - When top drive switch is in the enable position, the motor heater should be off and the heater should read approximately 65-ohms between terminals 5 to 8.
9. Update schematics in local manual by redlines (see Figure 2 on page 3).
10. Report completion of this bulletin to RIGLINE 24/7™ Support.
